AIRCRAFT CARGO COMPARTMENT FIRE TEST
SIMULATION PROGRAM

R. E. Blumke
McDonnell Douglas Corporation
Douglas Aircraft Company
3855 Lakewood Blvd.
Long Beach, California 90846

NAS2-8699
CR151951-NASA Report Number
January 1977

Final Report for Period October 1974 - January 1977

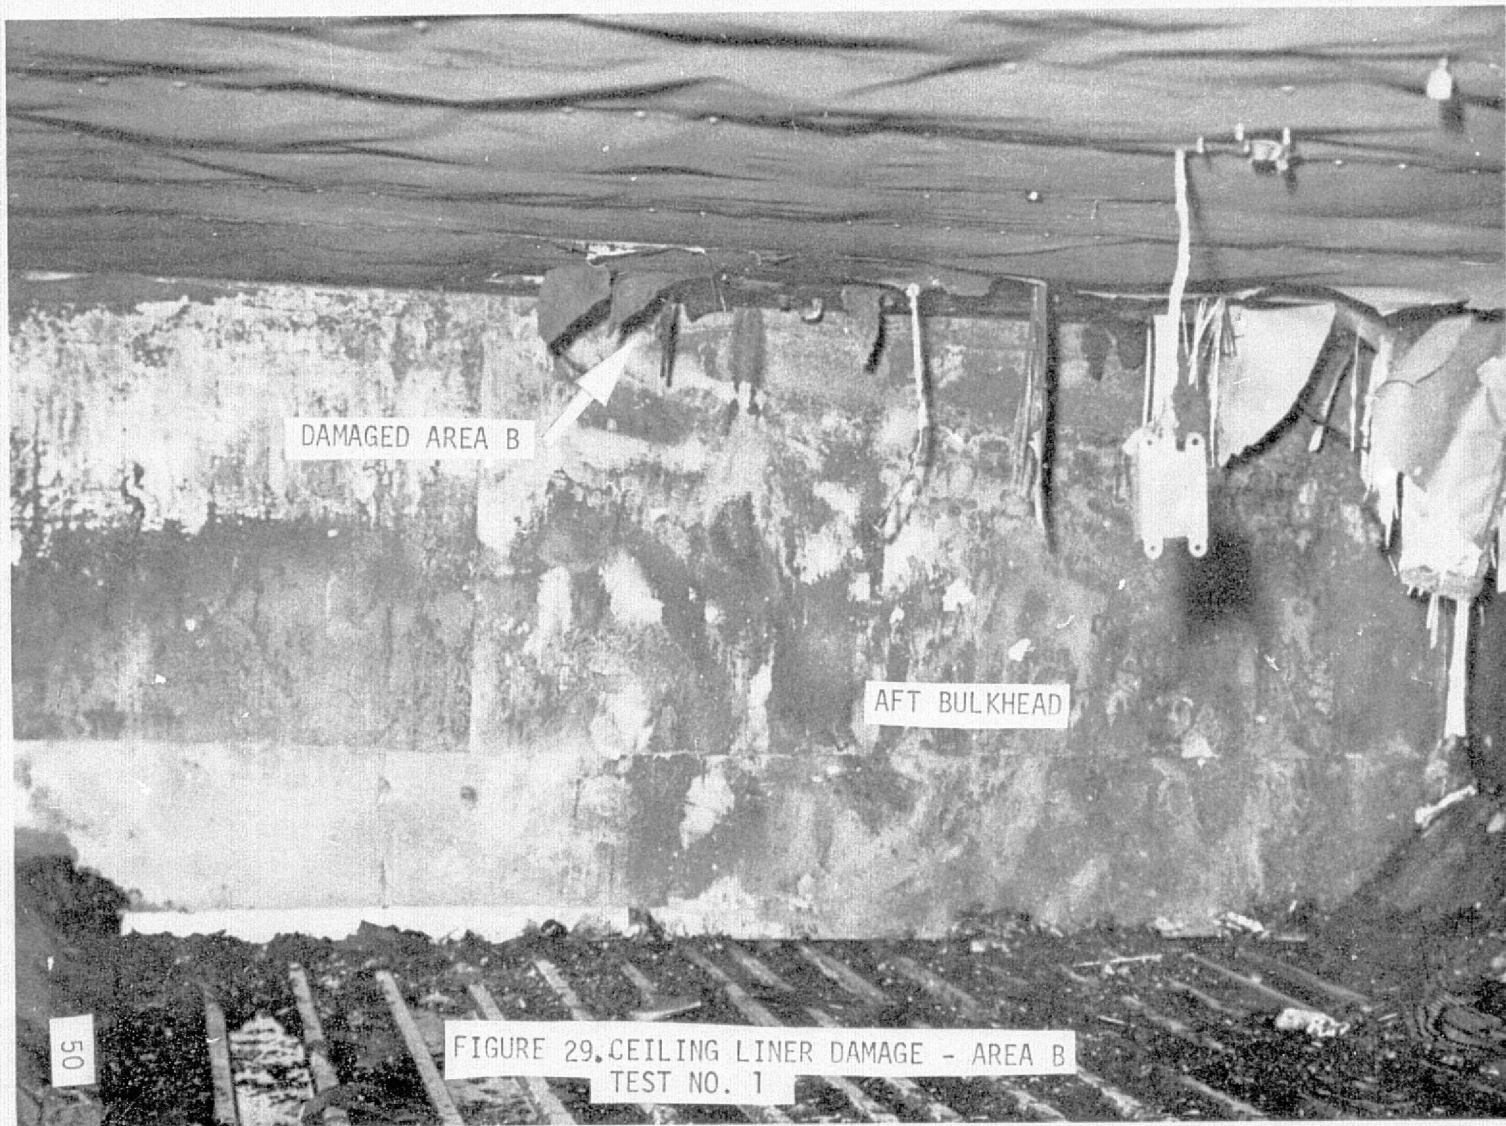
Post-test examination revealed two holes burned through the ceiling liner adjacent to the vent inlet. The holes were approximately 55.88cm x 55.88cm (22 x 22 inches) and 25.4cm x 50.8cm (10 x 20 inches) as shown in Figures 4, 28 and 29. Though extensive areas of the ceiling and sidewall liner were delaminated and baked free of resin, no other burnthroughs existed.

FIGURE 29. CEILING LINER DAMAGE - AREA B
TEST NO. 1

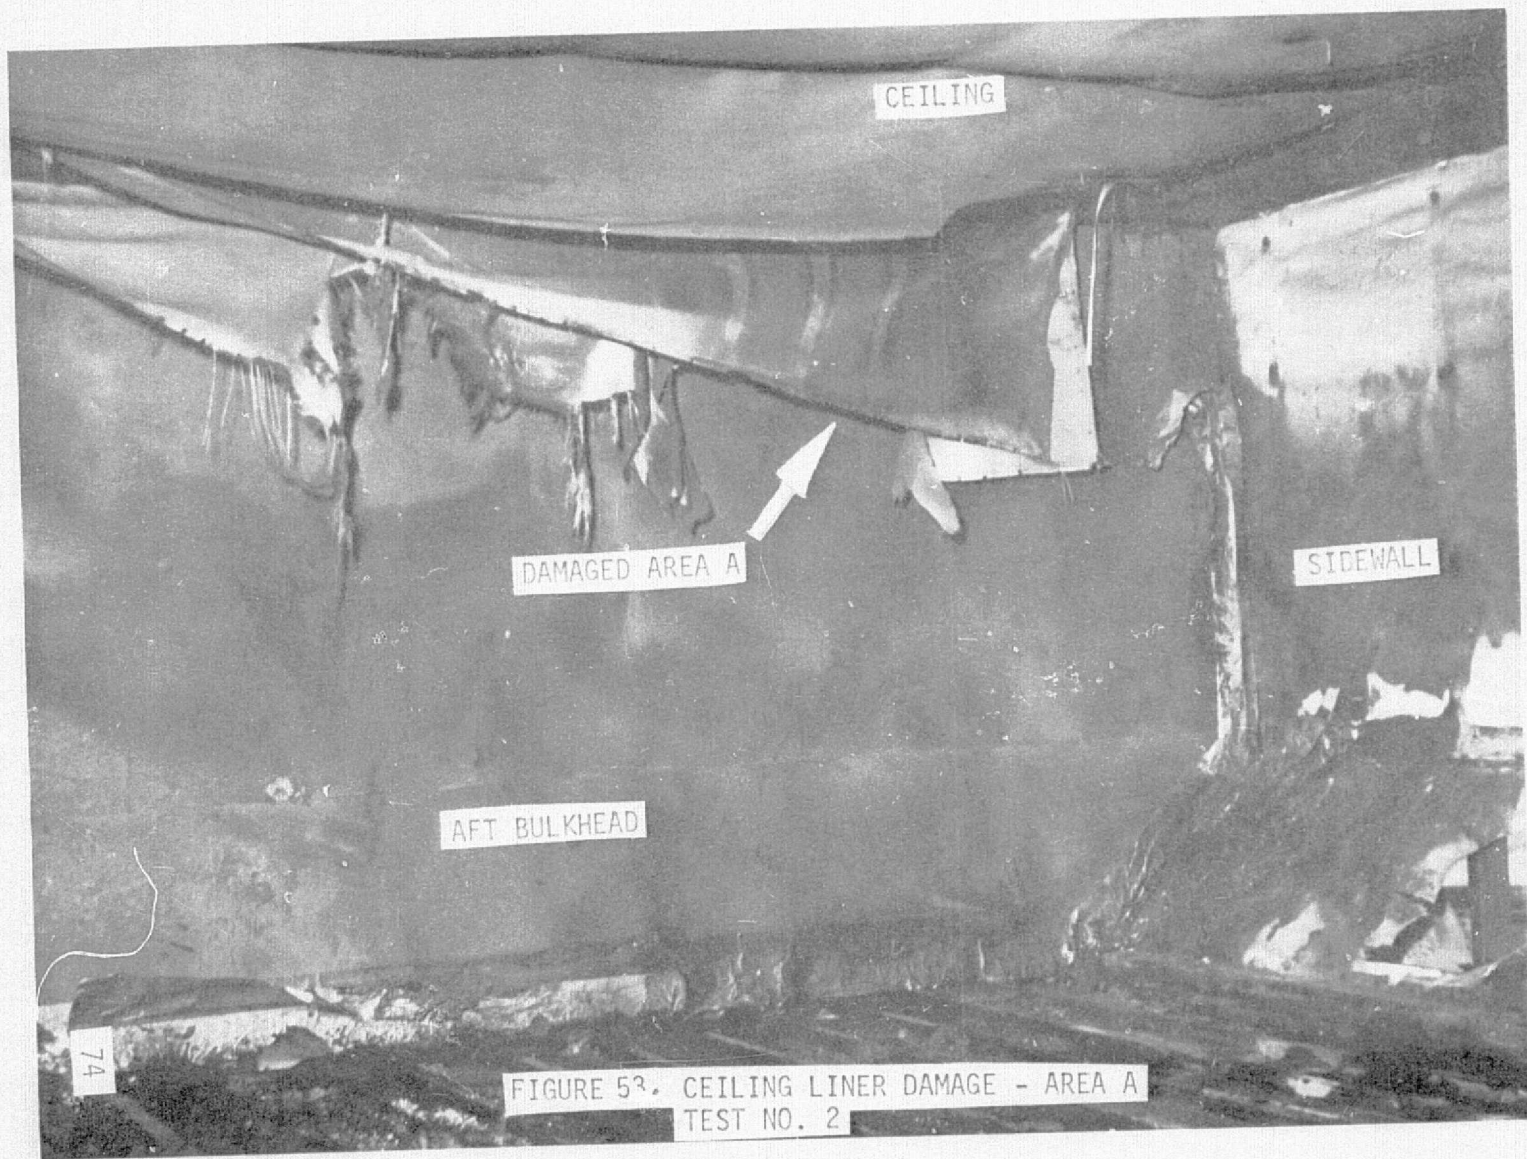
Figures 52 through 56 show the ceiling liner damage. The greatest damage occurred adjacent to and in front of the airflow inlet where the fire was centered. The ceiling area over the ignition source did not burn through. When the resin in the fiberglass bakes free only the fiberglass mat remains. This mat without the resin has little strength. The weight of the fiberglass panel causes the structural attachments to shear through the mat and the panel falls and hangs into the compartment, see Figure 53. New design techniques for attachment should be considered and tested in future programs. A split 7.62cm x 33cm (3 in. x 13 in.) occurred in the ceiling

FIGURE 53. CEILING LINER DAMAGE - AREA A
TEST NO. 2

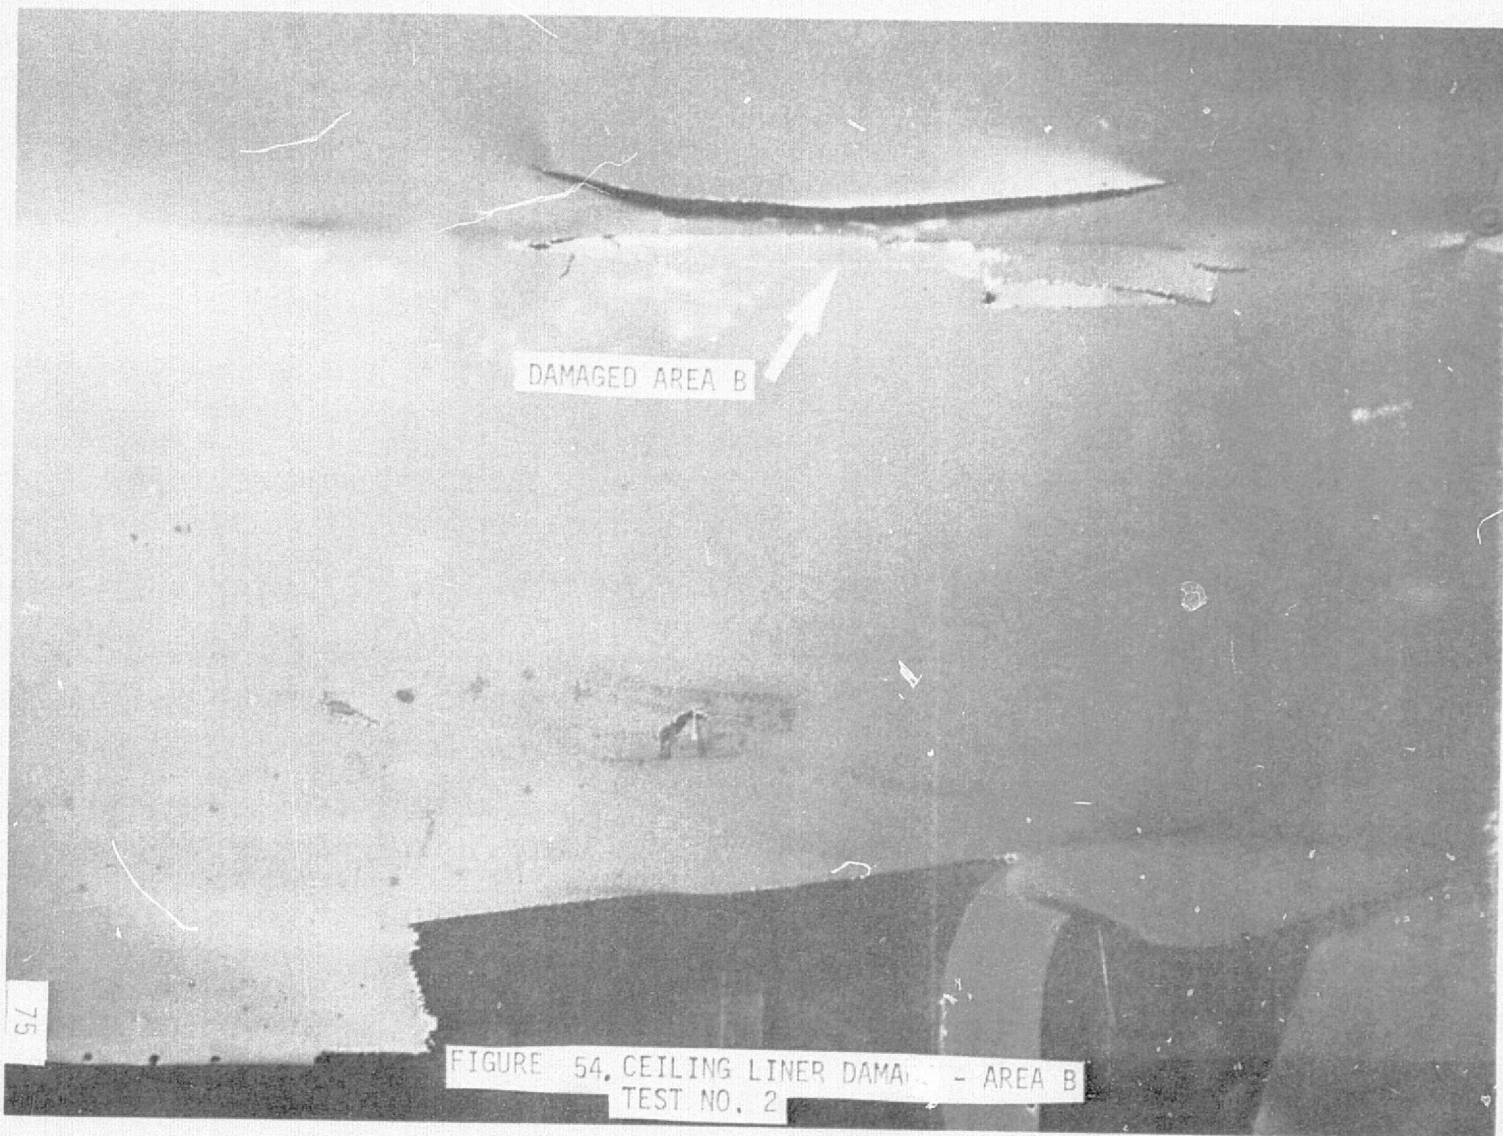
FIGURE 54. CEILING LINER DAMAGE - AREA B
TEST NO. 2

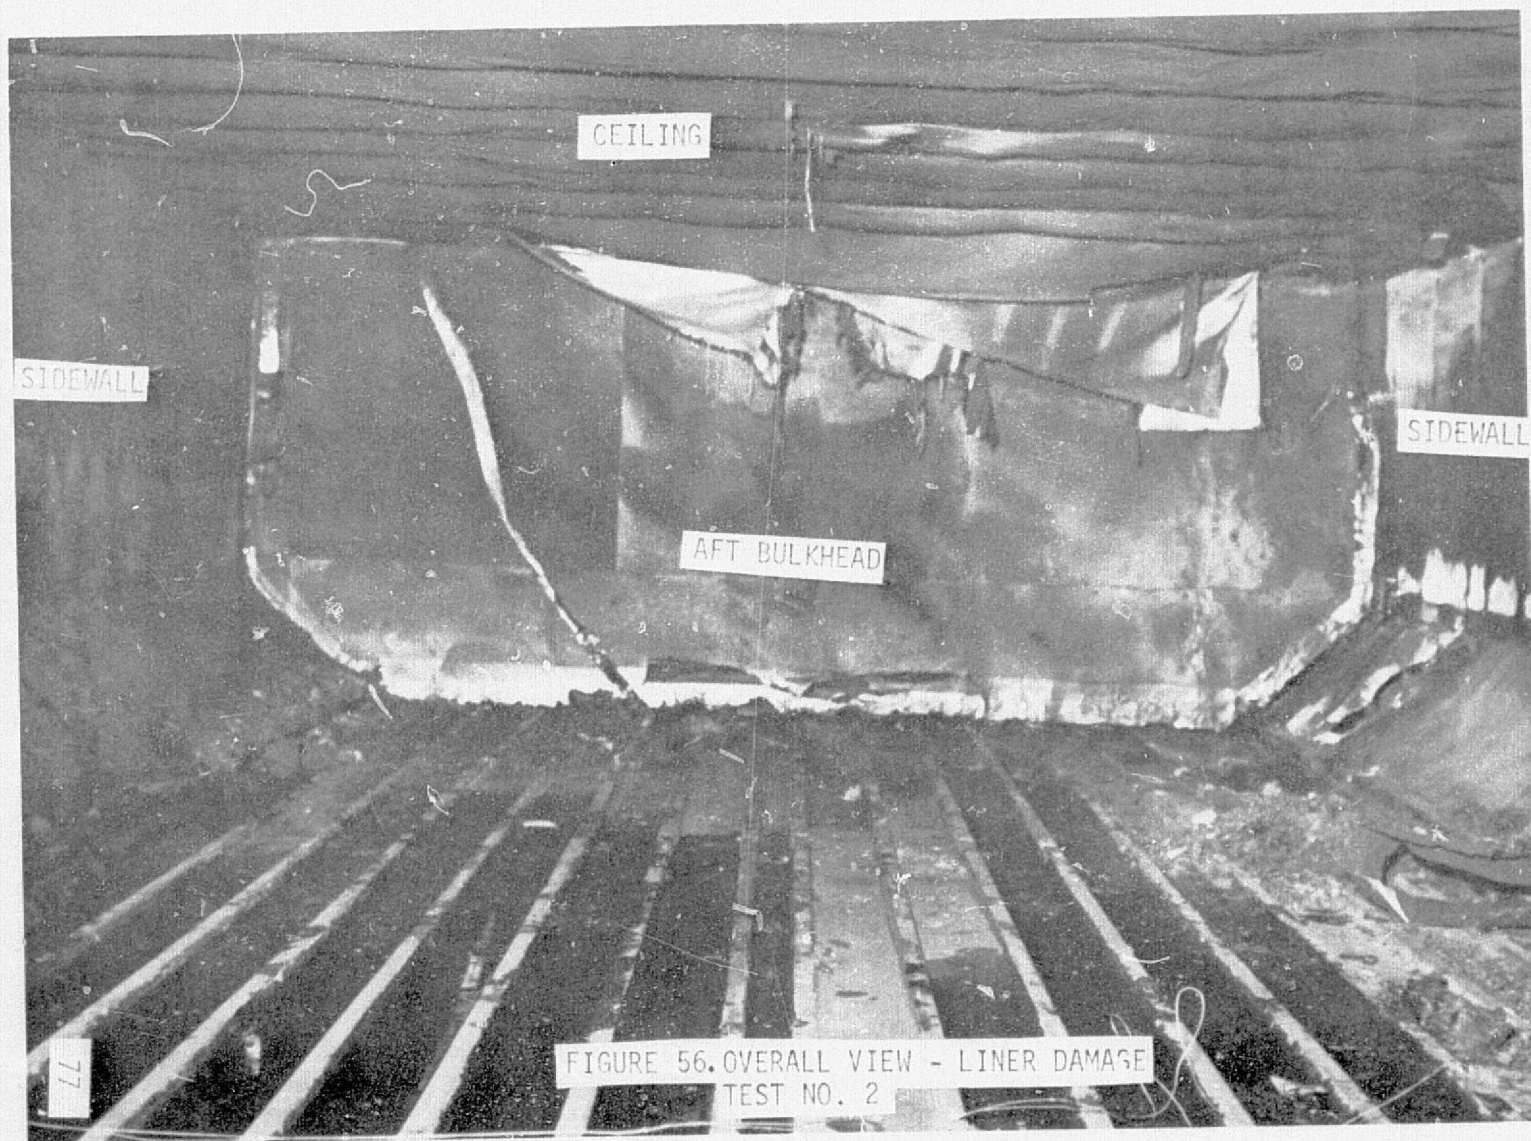
Extensive areas of the ceiling were delaminated and baked free of resin but no other burnthroughs existed. The sidewall liner above the inlet also showed delamination and was baked free of resin but no burnthroughs; see Figure 6. Although the resin bakes free from the fiberglass the mat remains and provides an effective barrier against flame penetration.

FIGURE 56. OVERALL VIEW - LINER DAMAGE
TEST NO. 2
